**Flood Control Project Maintenance  
Levee Inspections**

**Maintenance Issue Types Only, Levee Inspection Report By Mile - Fall 2014**

**Reclamation District No. 2063 Crows Landing**

Waterway	Bank	Unit Miles	Inspection Start/End	Inspector
Unit No. 01 San Joaquin River	Right	10.44	11/20/2014 11/20/2014	Richard Willoughby

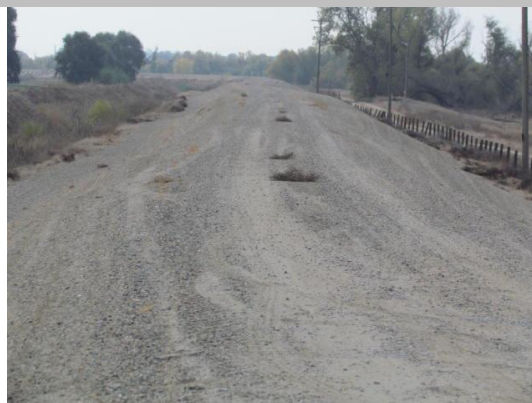
Photo 1 of 1 : FA\_2014\_RD2063\_112\_3\_20141103\_00001.jpg

LM Start	0.02	Rating **	A/W	Issue No.	3
LM End	0.51	Issue Type +	Ma	Location *	WS
Category	Earthen Levee			GPS Latitude/Longitude	
				Start	End
Item	Vegetation			37.478550 °	37.471548 °
				-121.044603 °	-121.044553 °
DWR ID	DWR_RD2063_01_s_2012_3				
Action/Comments					
Remove the wild growth other than native grasses from the levee slopes.

Looking south at typical view of waterside and landside slopes.

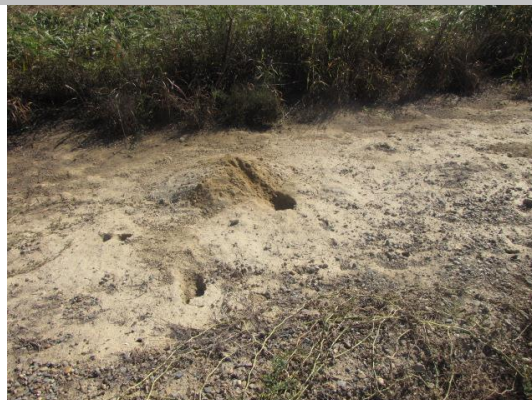
Photo 1 of 1 : FA\_2014\_RD2063\_112\_11\_20141103\_00004.jpg

LM Start	1.69	Rating **	A/W	Issue No.	11
LM End	1.69	Issue Type +	Ma	Location *	LS
Category	Earthen Levee			GPS Latitude/Longitude	
				Start	End
Item	Animal Control			37.459813 °	37.459813 °
				-121.032372 °	-121.032372 °
DWR ID	DWR_RD2063_01_s_2012_11				
Action/Comments					
No rodents visible, but rodent burrows visible; need to backfill and compact or grout burrows.

Looking east at squirrel holes on landside slope.

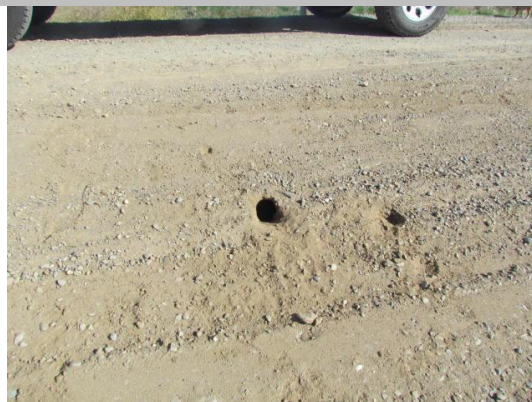
Photo 1 of 1 : FA\_2014\_RD2063\_112\_53\_20141120\_00049.jpg

LM Start	3.55	Rating **	M	Issue No.	53
LM End	3.55	Issue Type +	Ma	Location *	WS
Category	Earthen Levee			GPS Latitude/Longitude	
				Start	End
Item	Animal Control			37.438697 °	37.438697 °
				-121.019232 °	-121.019232 °
DWR ID	DWR_RD2063_01_f_2014_53				
Action/Comments					
Exterminate rodents and backfill and compact or grout burrows. Inspector Comments: Typical view of rodent holes on landward slope.

Looking north at typical view of rodent holes on waterward slope.

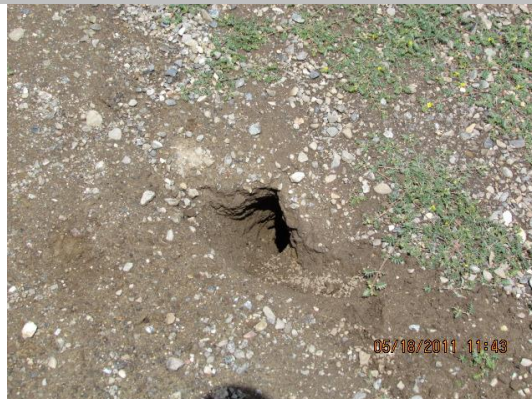
Photo 1 of 1 : FA\_2014\_RD2063\_112\_29\_20141103\_00014.jpg

LM Start	3.77	Rating **	A/W	Issue No.	29
LM End	3.82	Issue Type +	Ma	Location *	LS
Category	Earthen Levee			GPS Latitude/Longitude	
				Start	End
Item	Animal Control			37.436197 °	37.435732 °
				-121.016937 °	-121.016090 °
DWR ID	DWR_RD2063_01_s _ 2012_29				
Action/Comments					
No rodents visible, but rodent burrows visible; need to backfill and compact or grout burrows.

Looking at typical view of a squirrel hole on landside shoulder.

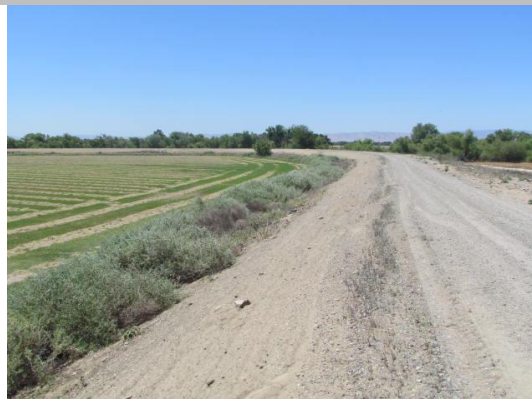
Photo 1 of 1 : FA\_2014\_RD2063\_112\_120\_20141103\_00030.jpg

LM Start	6.15	Rating **	A/W	Issue No.	120
LM End	6.36	Issue Type +	Ma	Location *	LS
Category	Earthen Levee			GPS Latitude/Longitude	
				Start	End
Item	Vegetation			37.415488 °	37.413473 °
				-120.998988 °	-121.001680 °
DWR ID	DWR_RD2063_01_s_2012_120				
Action/Comments					
Remove the wild growth other than native grasses from the levee slopes.

Looking south at dense vegetation on landside toe.

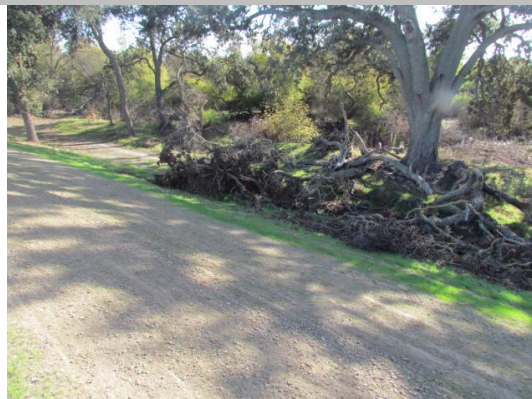
Photo 1 of 1 : FA\_2014\_RD2063\_112\_6\_20141120\_00051.jpg

LM Start	7.48	Rating **	M	Issue No.	6
LM End	7.48	Issue Type +	Ma	Location *	WS
Category	Earthen Levee			GPS Latitude/Longitude	
				Start	End
Item	Encroachments			37.404377 °	37.404377 °
				-120.988852 °	-120.988852 °
DWR ID	DWR_RD2063_01_f_2014_6				
Action/Comments					
Tree or limb					
Inspector Comments: Fallen tree limbs at waterward toe.

Looking southwest at fallen tree limbs at waterward toe.

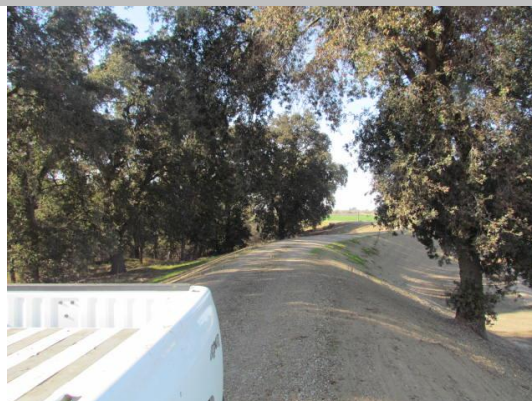
Photo 1 of 1 : FA\_2014\_RD2063\_112\_7\_20141120\_00052.jpg

LM Start	7.69	Rating **	M	Issue No.	7
LM End	7.69	Issue Type +	Ma	Location *	LS
Category	Earthen Levee			GPS Latitude/Longitude	
				Start	End
Item	Trim / Thin Trees			37.403516 °	37.403516 °
				-120.985718 °	-120.985718 °
DWR ID	DWR_RD2063_01_s_2012_7				
Action/Comments					
Trim trees over roadway to at least 12 feet above ground level.

Looking north at overhanging tree on landward slope.
